HYDRO-ELECTRIC INQUIRY COMMISSION

THE QUEENSTON-CHIPPAWA POWER DEVELOPMENT

CHAPTER "H"—CONSTRUCTION PLANT

INTAKE, WELLAND RIVER, FOREBAY, POWER HOUSE AND TAILRACE

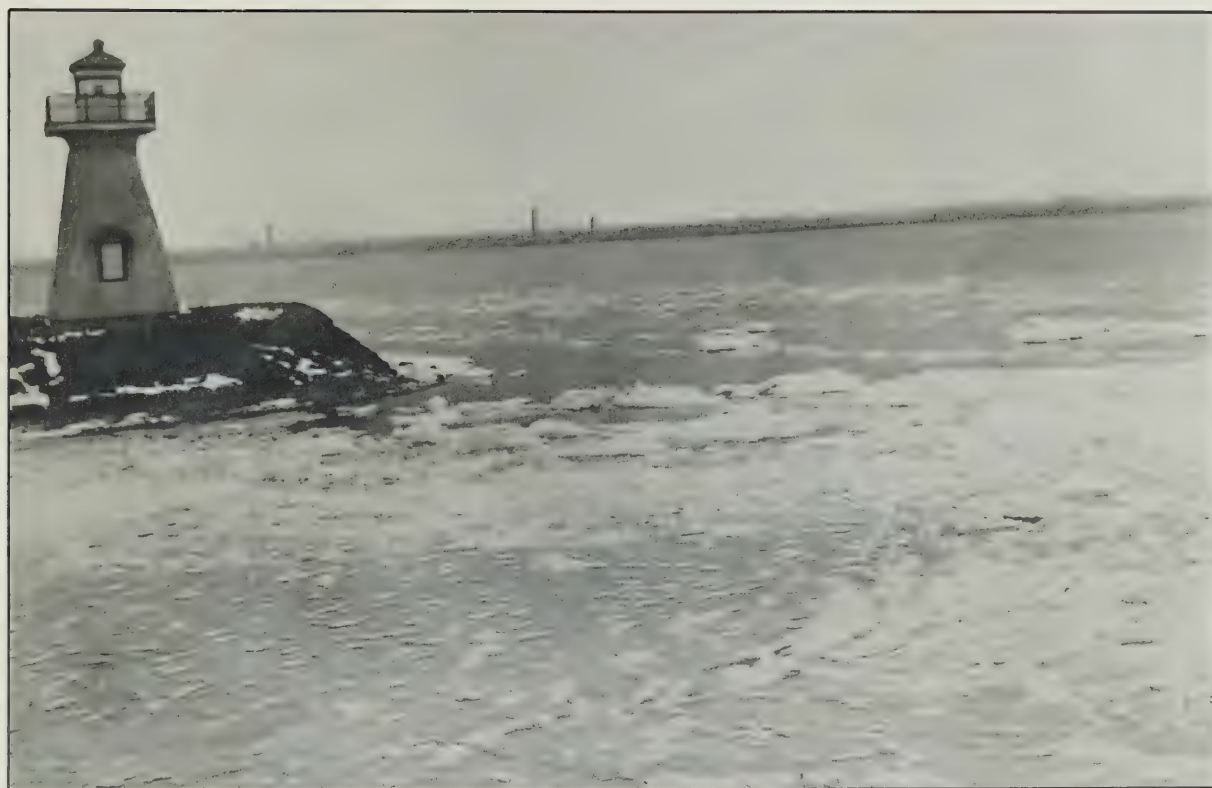
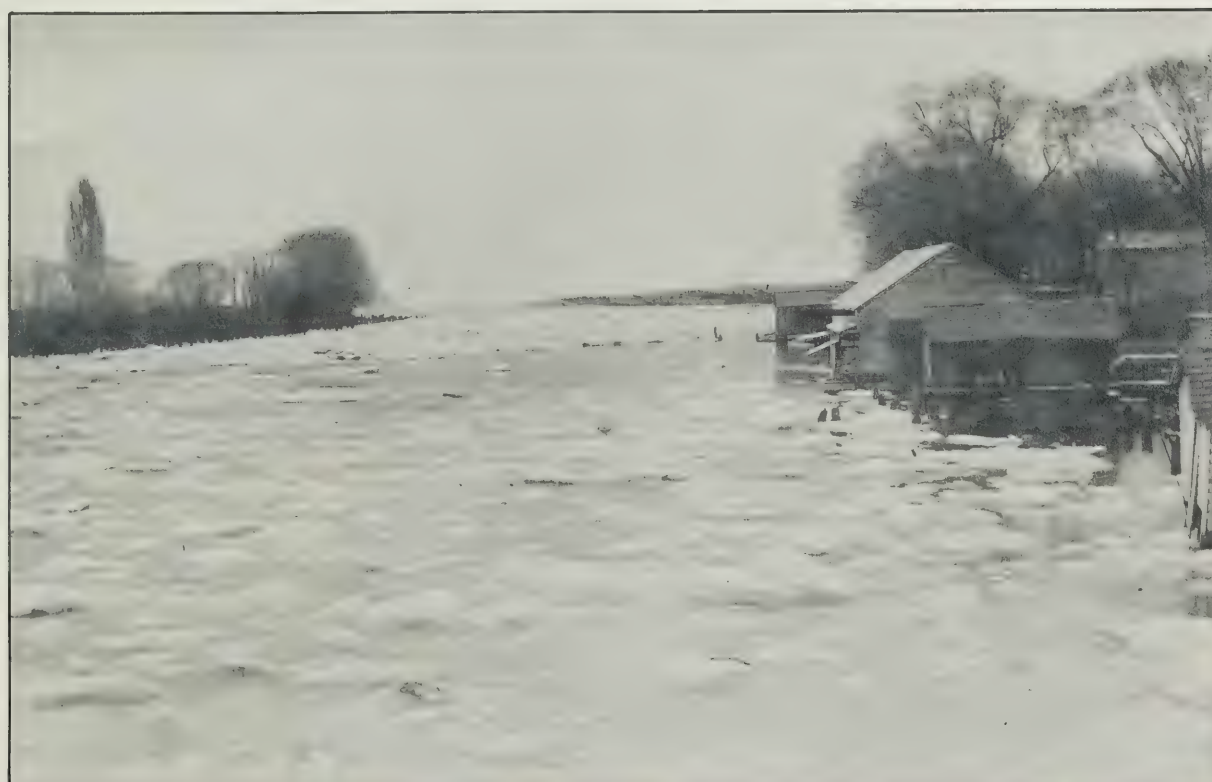
No. H-83

Niagara River Drift Ice in Welland River Channel.

looking easterly. Strong easterly wind.

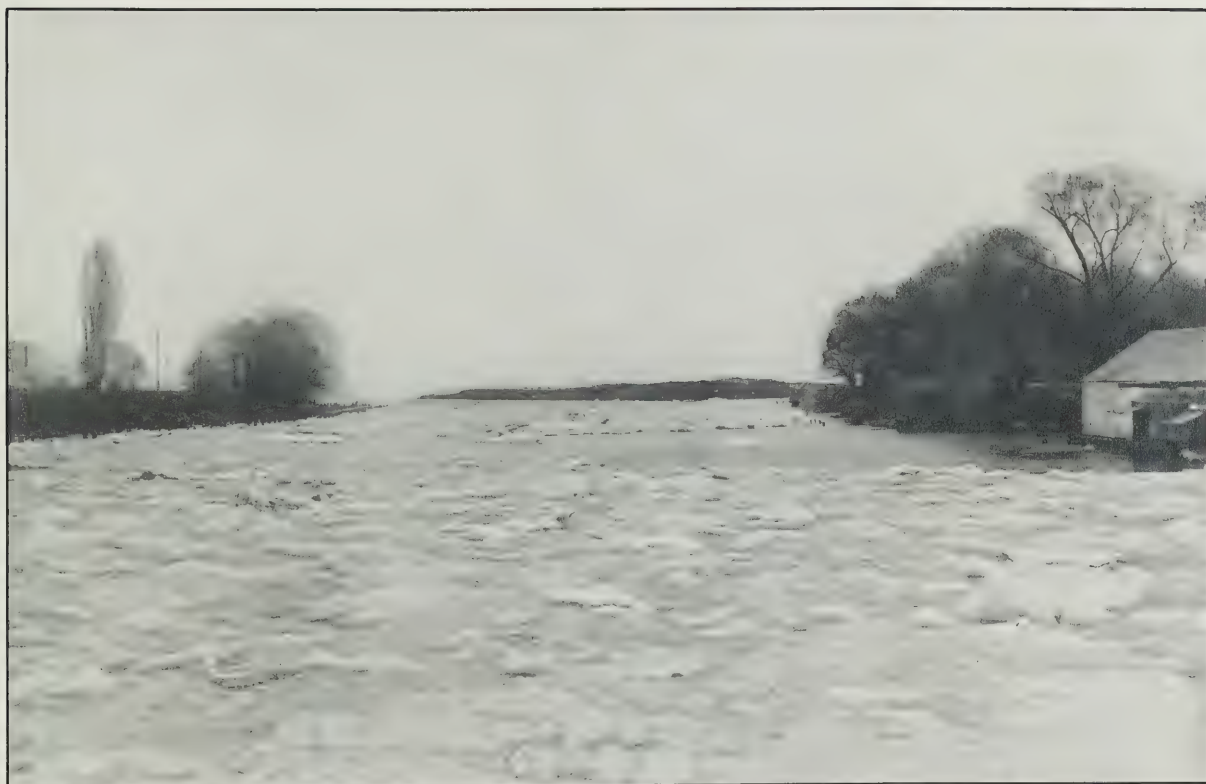
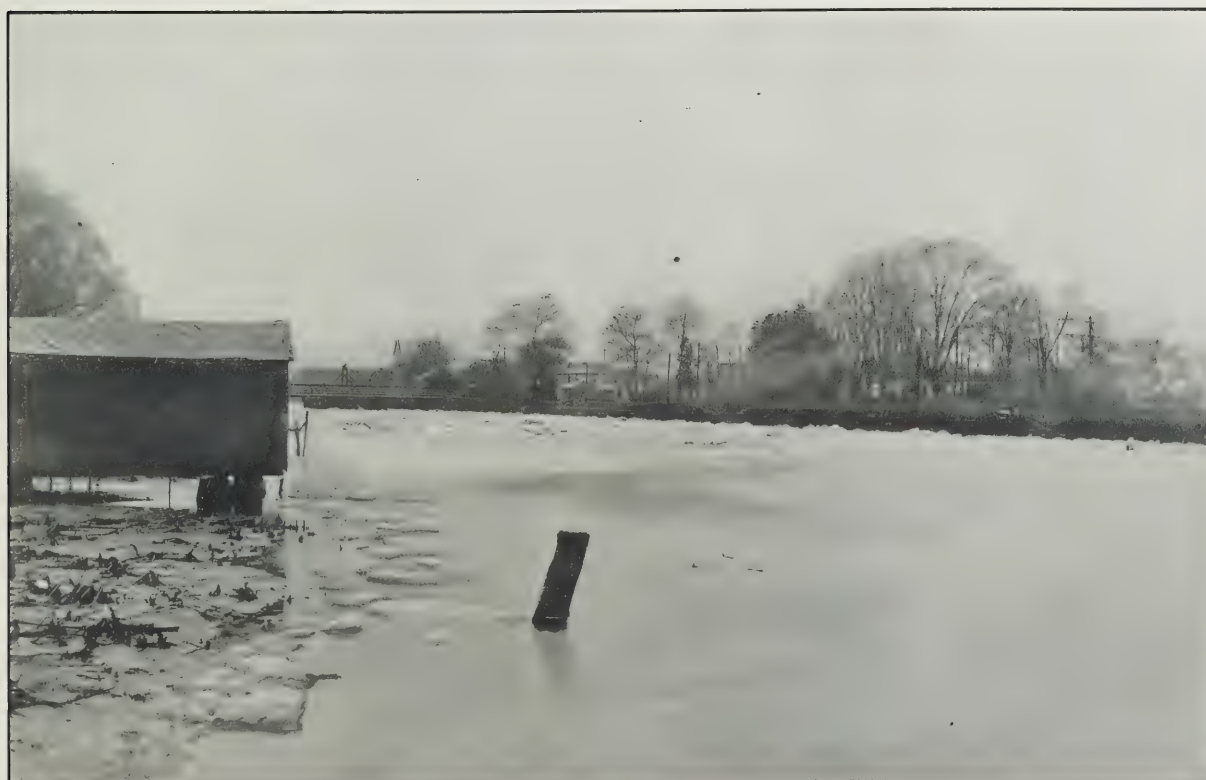
No. H-85

Niagara River Drift Ice in Welland River Channel.

looking westerly. Strong easterly wind.

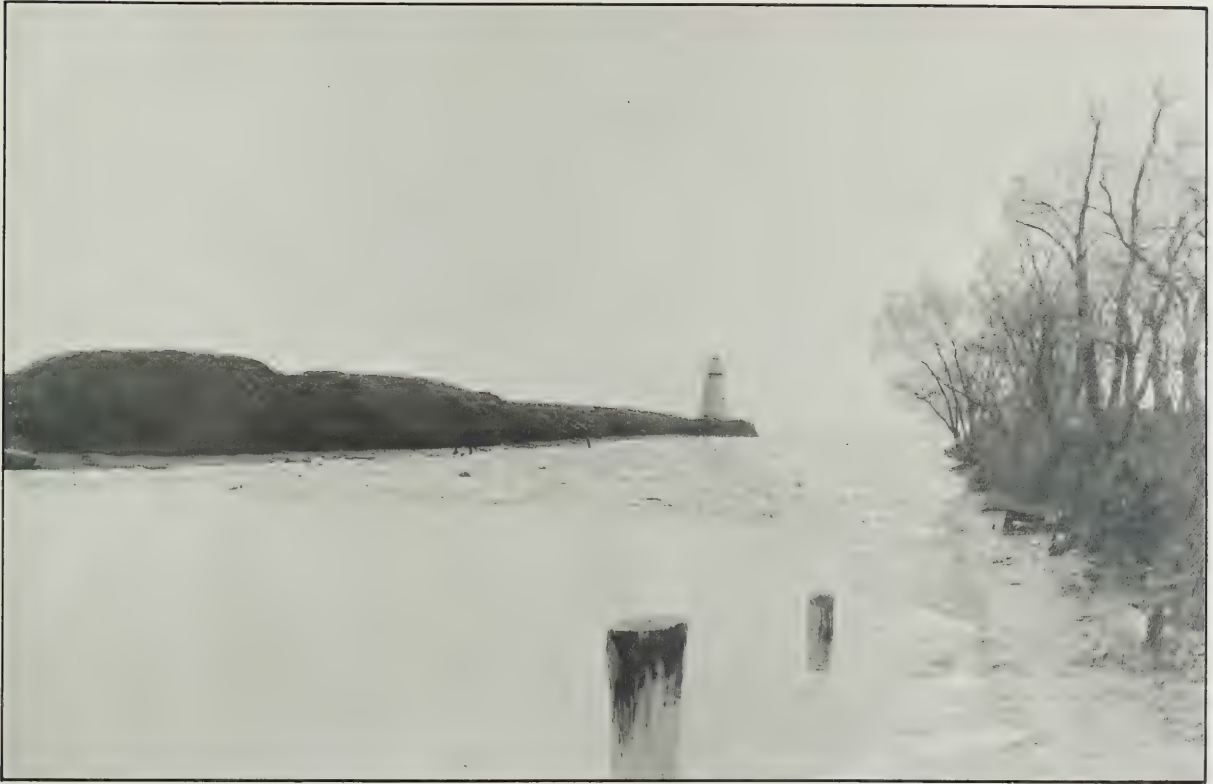
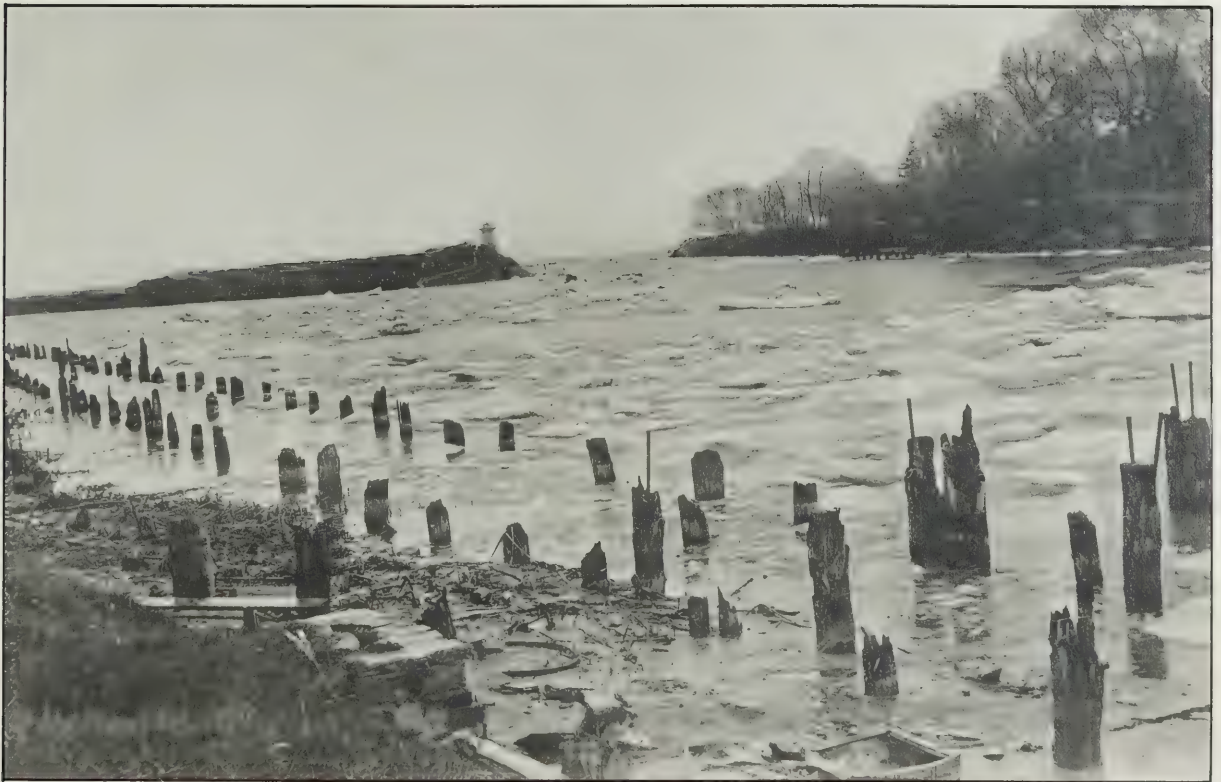
No. H-87

Niagara River Drift Ice in Welland River Channel.

looking easterly. Strong easterly wind.

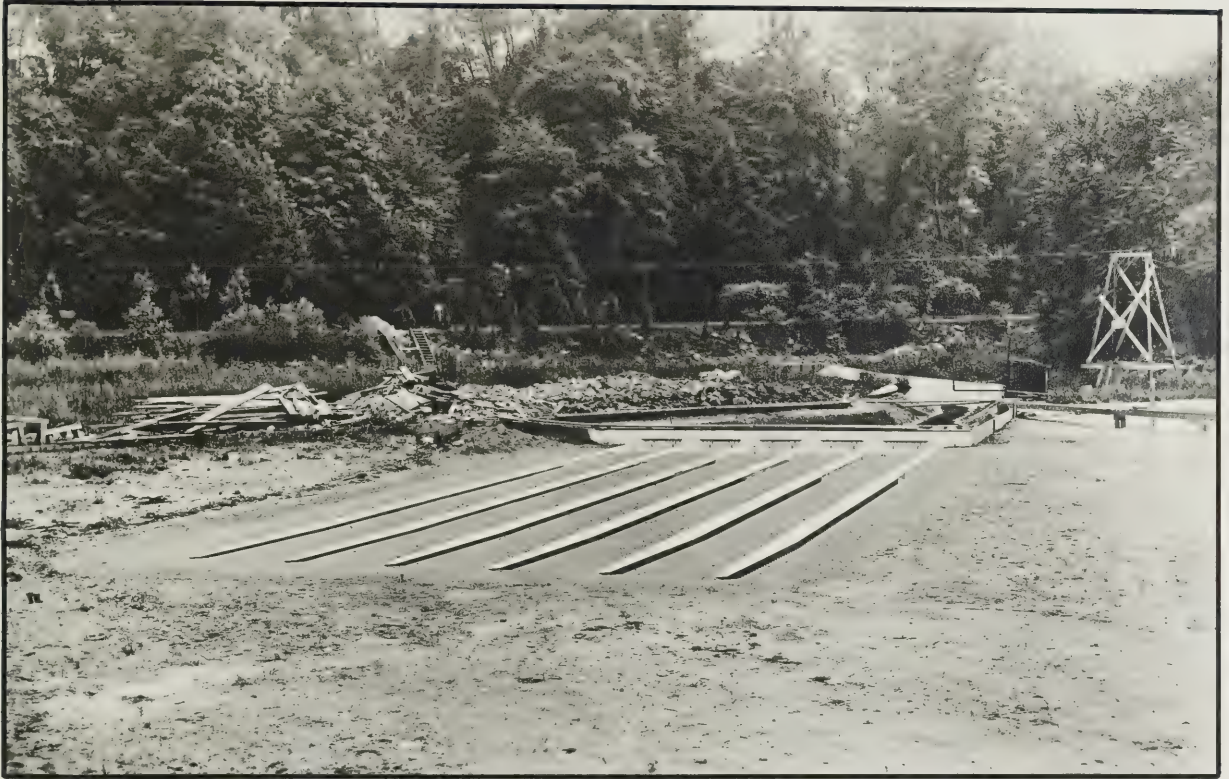
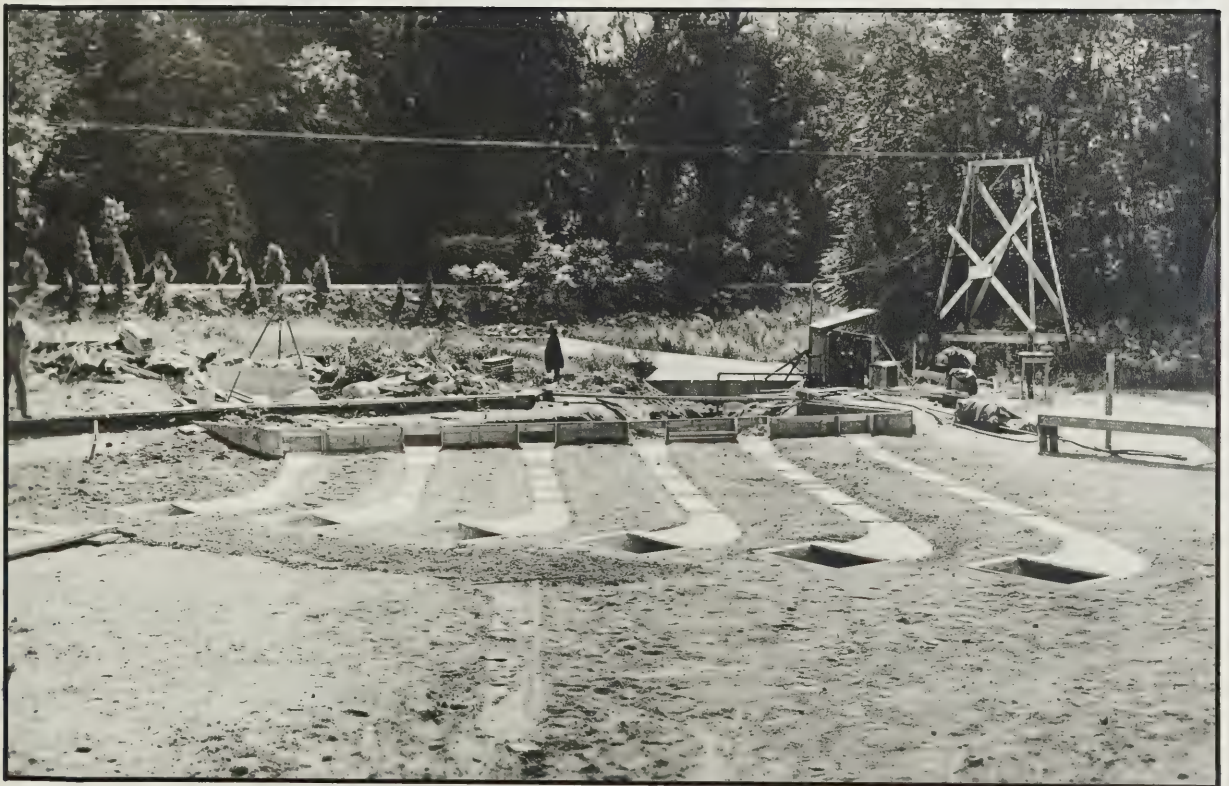
No. H-89

Model for Intake Tubes at Dufferin Islands,
end openings only.

Taken September 18th, 1919.

and the velocities were correspondingly reduced. Photographs Nos. H-88 and H-89 on page H-162 hereof show the character of the work on the models, the lower picture being that of a series of tests which indicated that it was impossible to obtain the desired results by single openings at the outer ends of the admission tubes. The upper picture shows the model tubes which were devised and which proved that it was possible to so design the admission openings throughout the length of the tube that the water could be received from the bottom of the stream in equal volume per unit of length of tube.

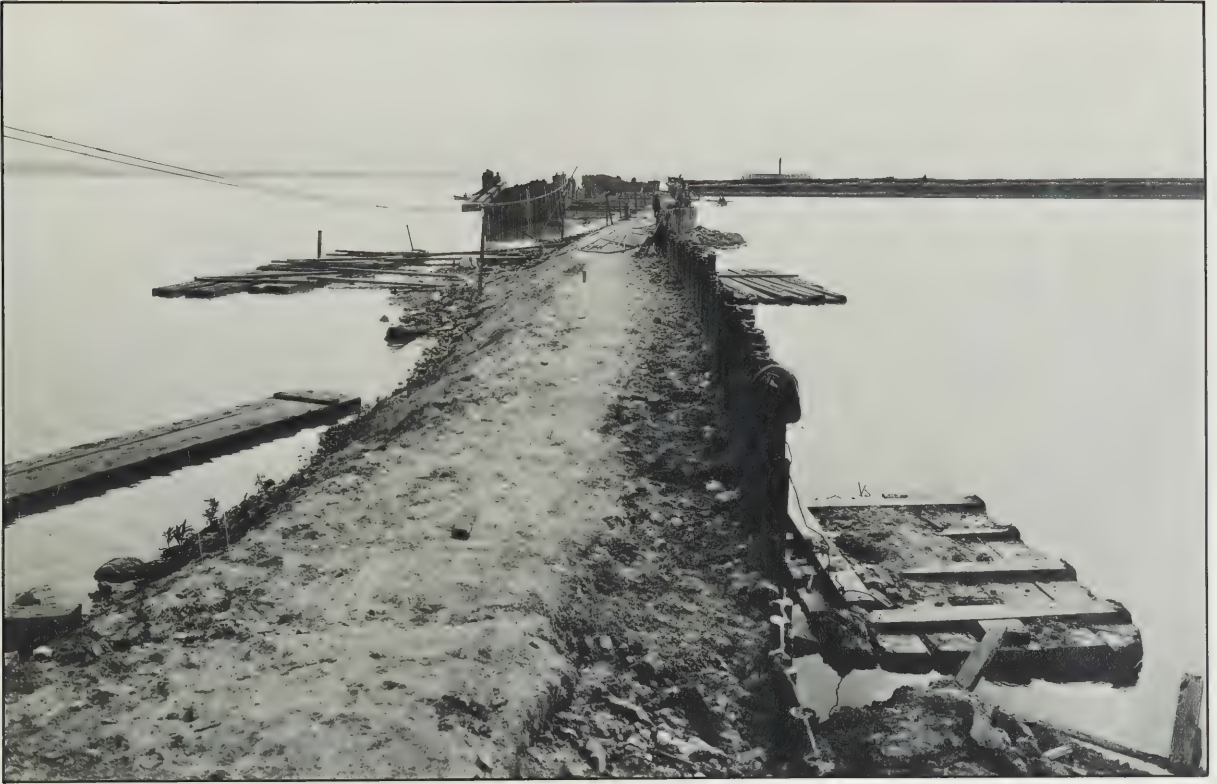
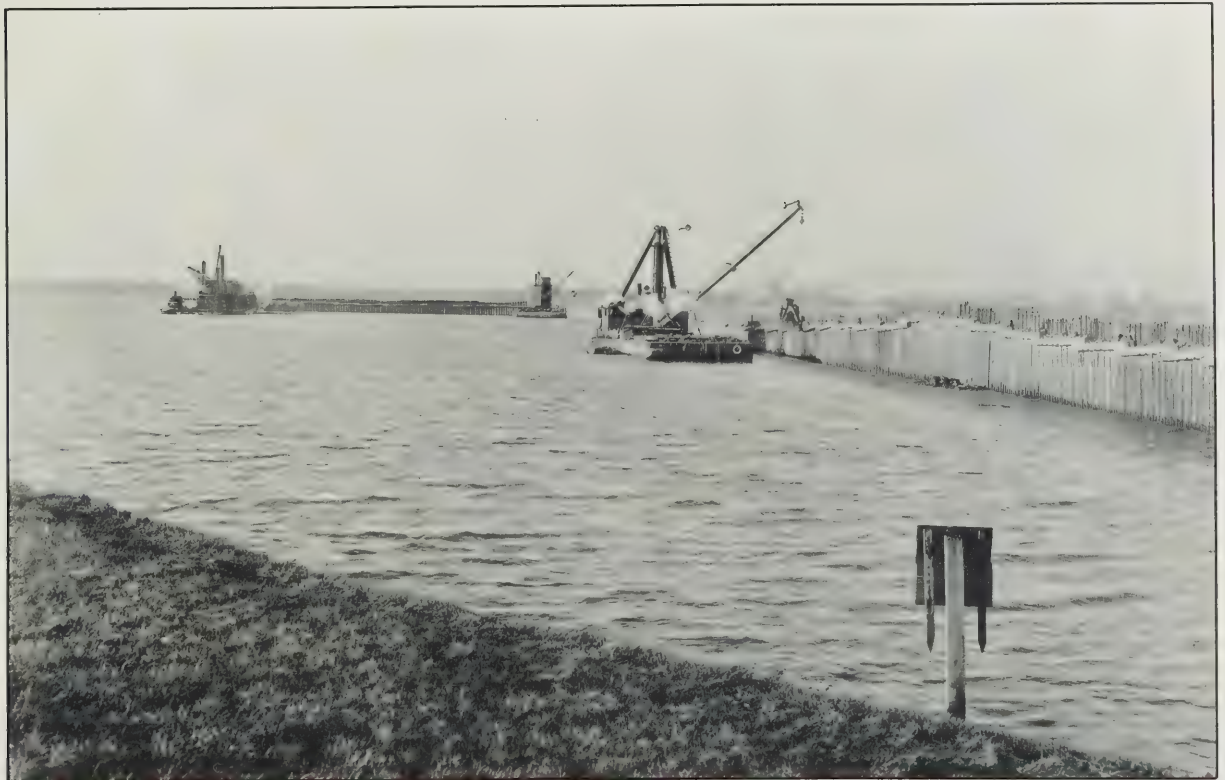
No. H-91

Temporary Dam Construction and Dredging
at Intake.

Taken December 2nd, 1920.

which increased in density and hardness near the rock surface. In order to provide a dry site for the subsequent erection of the concrete Intake structure, a temporary dam was built from the north-easterly side of Hog Island outside the line of the structure and joining with the westerly shore of the River. The dam was built by driving a line of steel sheet piling down the centre of the chosen location, and depositing the earth spoil from the dredging on either side of the sheet piling. For part of the length of the dam a double row of steel piling was driven. The construction of the dam may be seen by reference to Photographs Nos. H-90 and H-91, included as page H-164 hereof. The greater portion of the spoil from the Intake site was deposited in the Niagara River immediately downstream from Hog Island in the disposal area marked "C" on the plan included herewith as page H-165. From this source the disposal area "C" received 752,093 cubic yards of material. The spoil was transported from the excavating plant to its destination in bottom-dumping scows. In the early part of the work, the scows were dumped in the channel on the northerly side of Hog Island. At the later period they used the disposal area "C", being controlled in their course by a 2,000-foot cable anchored to a pier specially built in the river and operated by a Lidgerwood unloader as a safety precaution and for speedy manipulation, the current in the river being such that it was not feasible to handle the scows with tugs.

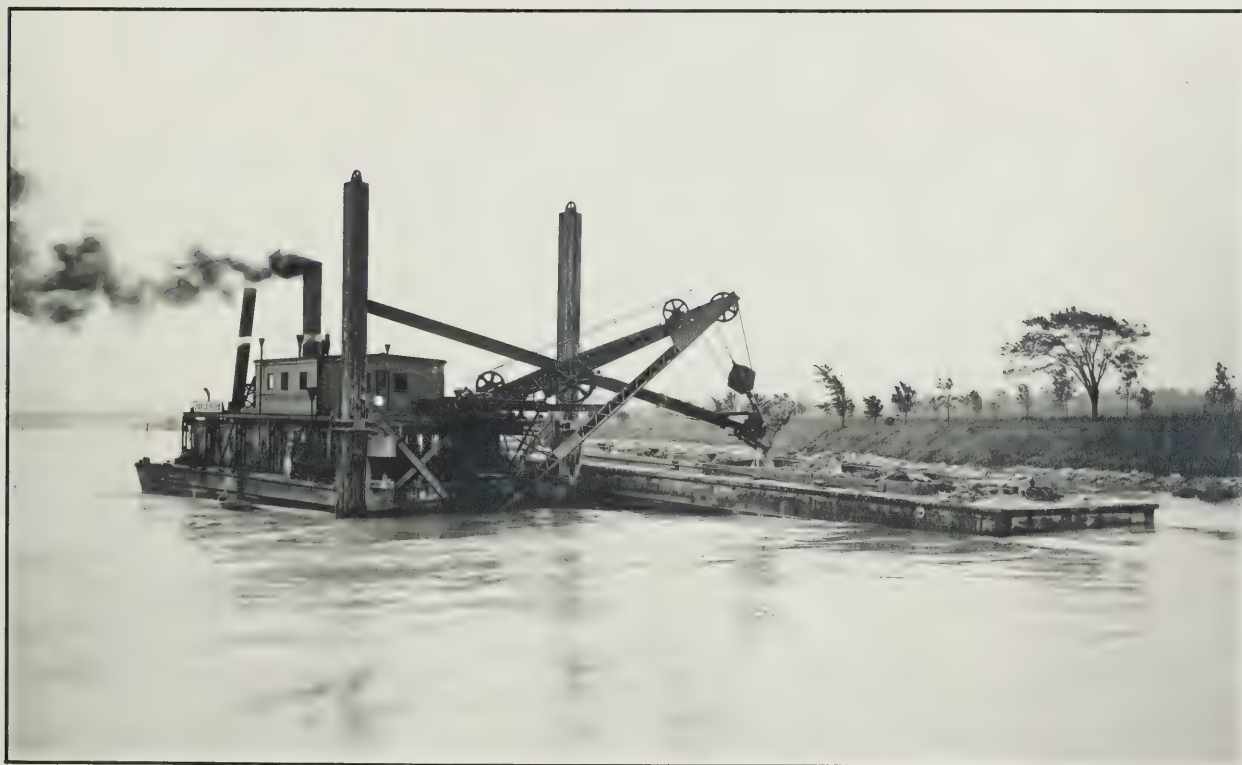
No. H-93

Dredge "Charles Boone" Working in Intake.

Taken September 18th, 1918.

A portion of the spoil was taken to the disposal area marked "A" on the plan already referred to, in bottom-dumping scows towed in the usual way by tugs. Two photographs, being No. H-92 and No. H-93, on page H-167 hereof, show the dredge "Charles Boone" in operation.

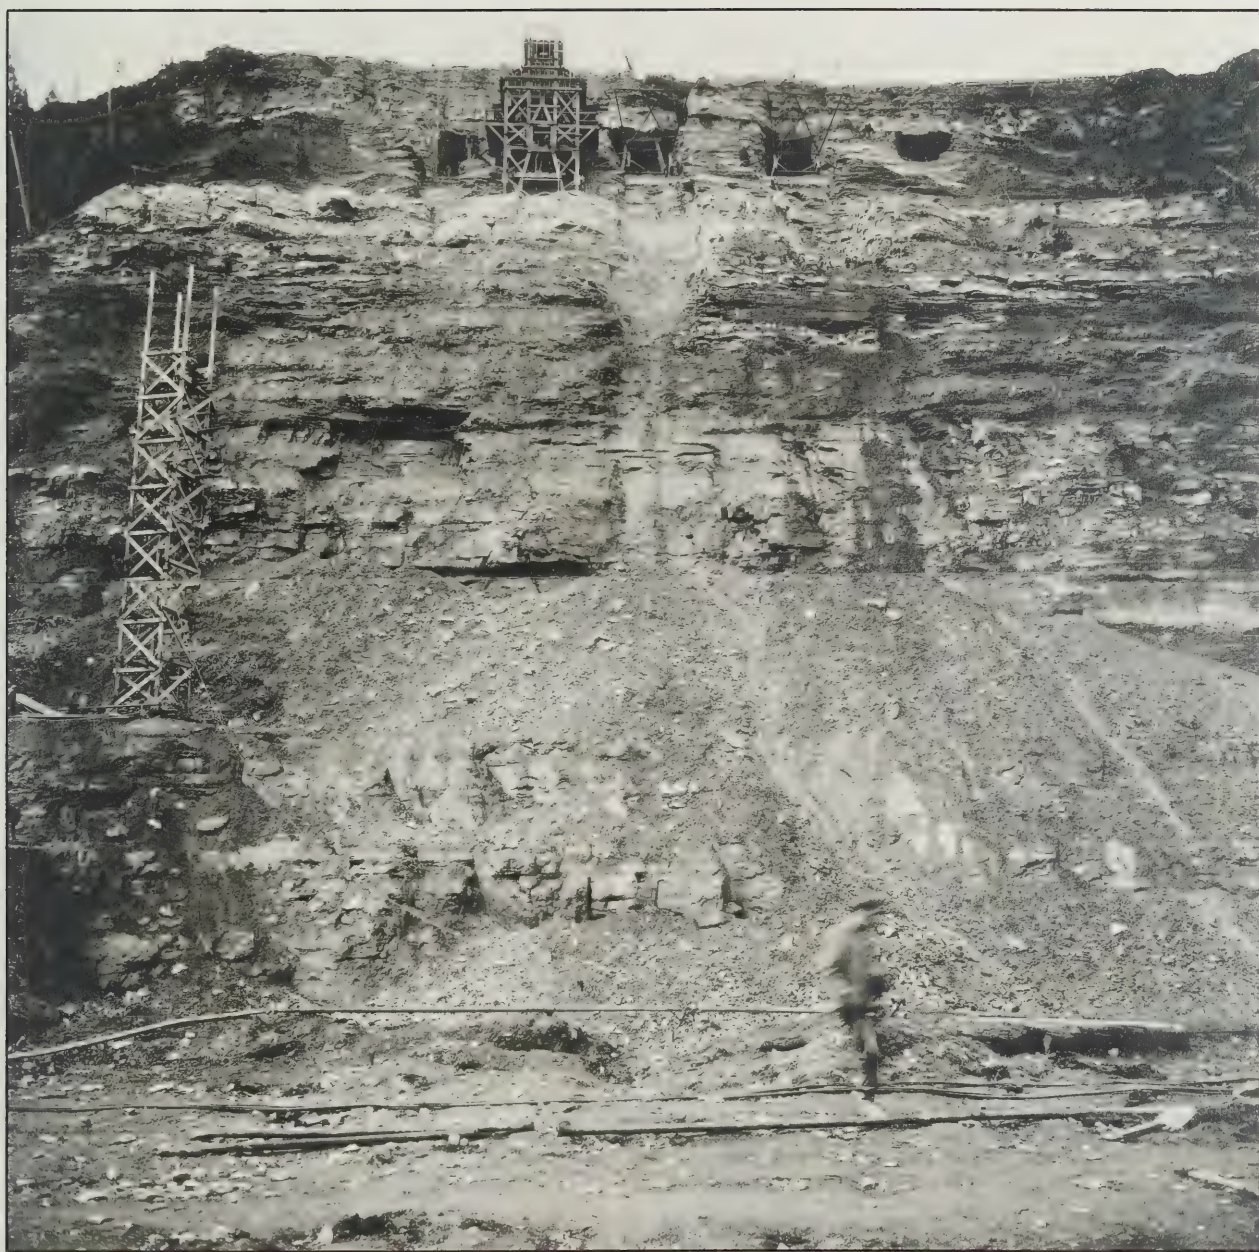
Trimming Work on Face of Cliff at Power House.

Taken November 3rd, 1920.

Gunite was applied also to the less durable portions of the trimmed surface of the cliff after the Power House, the Penstocks and the Promenade were completed. Practically no work was done on the face of the cliff except trimming and scaling by hand over those portions in the vicinity of the Power House building not occupied by the concrete envelopes of the Penstocks. The excavation for the penstock envelopes was carefully cut down by hand and light blasting.

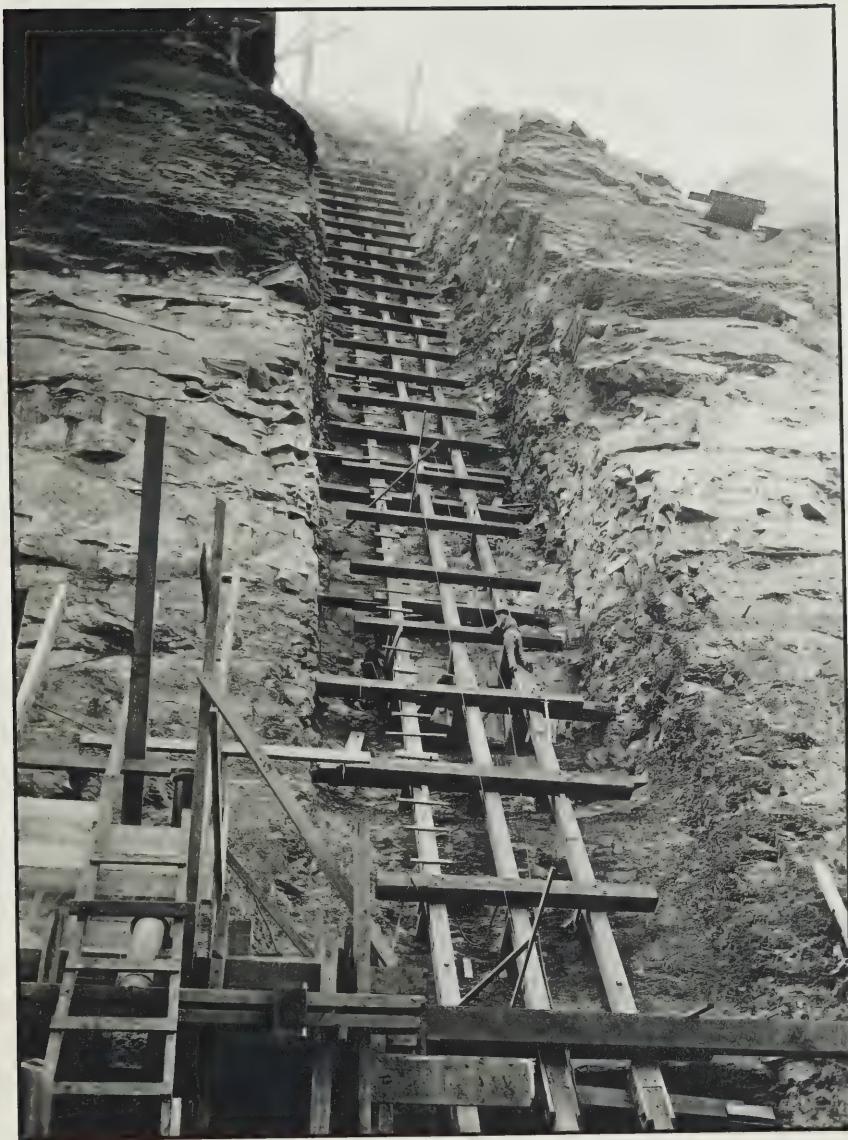
Penstock Chamel Trimmed in Face of Cliff,
at Power House .

Taken June 18th, 1921.

The excavation for the Penstocks was all in rock and involved two distinctly different construction methods. The horizontal section of the Penstocks from the Screen House on the face of the cliff was done by tunnelling, and the inclined portion over the face of the cliff was executed by careful close drilling, light blasting and hand trimming, the spoil being removed after it had dropped to the bottom of the gorge. Generally speaking, the face of the cliff was not removed, but was merely trimmed and adapted so that it would conform to the relative positions of the Screen House and Power House and the alignment of the Penstocks. The exposed faces of the crystalline rock were left in their natural condition, and the less durable rock above the power house roof was treated with gunite to prevent disintegration.
